Applies To: **2005–08 TL – ALL**
2008 MDX – ALL

HandsFreeLink (HFL) Doesn't Work, or Battery Is Too Low to Start the Engine

(Supersedes 08-057, dated July 14, 2012, to revise the information marked by the black bars)

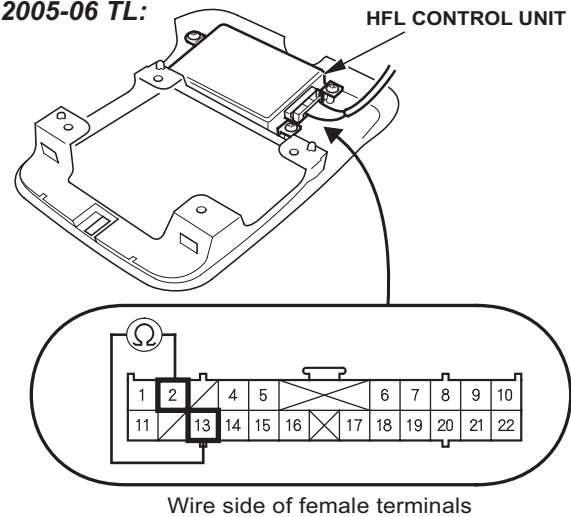
2005-06 TL:

6. **05–06 TL:** Disconnect the HFL control unit 22P connector, and measure the resistance between terminals No. 2 and No. 13 with an ohmmeter.

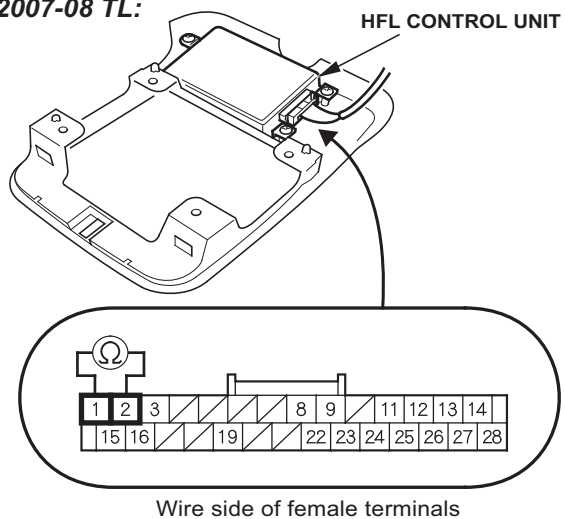
2007-08 TL:

07–08 TL: Disconnect the HFL control unit 28P connector, and measure the resistance between terminals No. 1 and No. 2 with an ohmmeter.

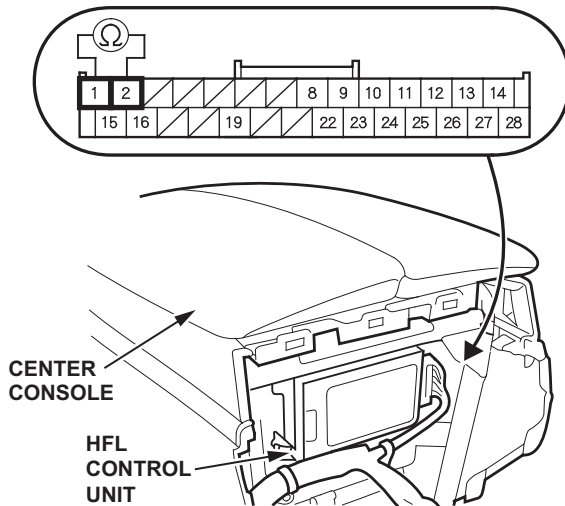
MDX:

MDX : Disconnect the HFL control unit 28P connector, and measure the resistance between terminals No. 1 and No. 2 with an ohmmeter.
